# Service Bulletin

<b>Subject:</b> <b>CLEARING ECCENTRIC SHAFT PLATE PROFILE MEMORY FROM PCM - SERVICE TIP</b>	<b>Bulletin No:</b> 01-007/04
	<b>Last Issued:</b> 2/9/2004

2004 RX-8

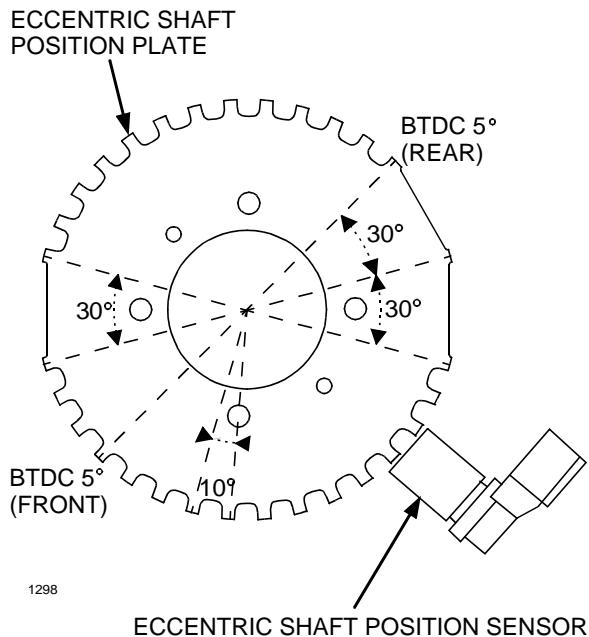
The RX8 is equipped with a unique system that memorizes the tooth pattern or "profile" of the eccentric shaft position plate. The eccentric shaft plate profile is stored in an area of the PCM with non-volatile RAM (NV RAM) which cannot be cleared by disconnecting the vehicle's battery, or clearing keep alive memory (KAM). If the eccentric shaft plate profile is not cleared after certain repairs, MIL illumination and misfire DTCs may occur.

Refer to the special procedure to clear the NV RAM after performing repairs with the following conditions:

- Removal / replacement of the eccentric shaft position sensor from the engine.
- Removal / replacement of the front pulley / eccentric shaft position plate from the engine.
- Removal / replacement of the engine.
- Replacement of the PCM.
- Performing repairs for engine misfire DTCs- P0300, P0301 and P0302.
